Site 200 Gloucester Water Pollution and Control Facility

Great Marsh Coastal Wetlands Restoration Plan Rapid Technical Assessment Site 200

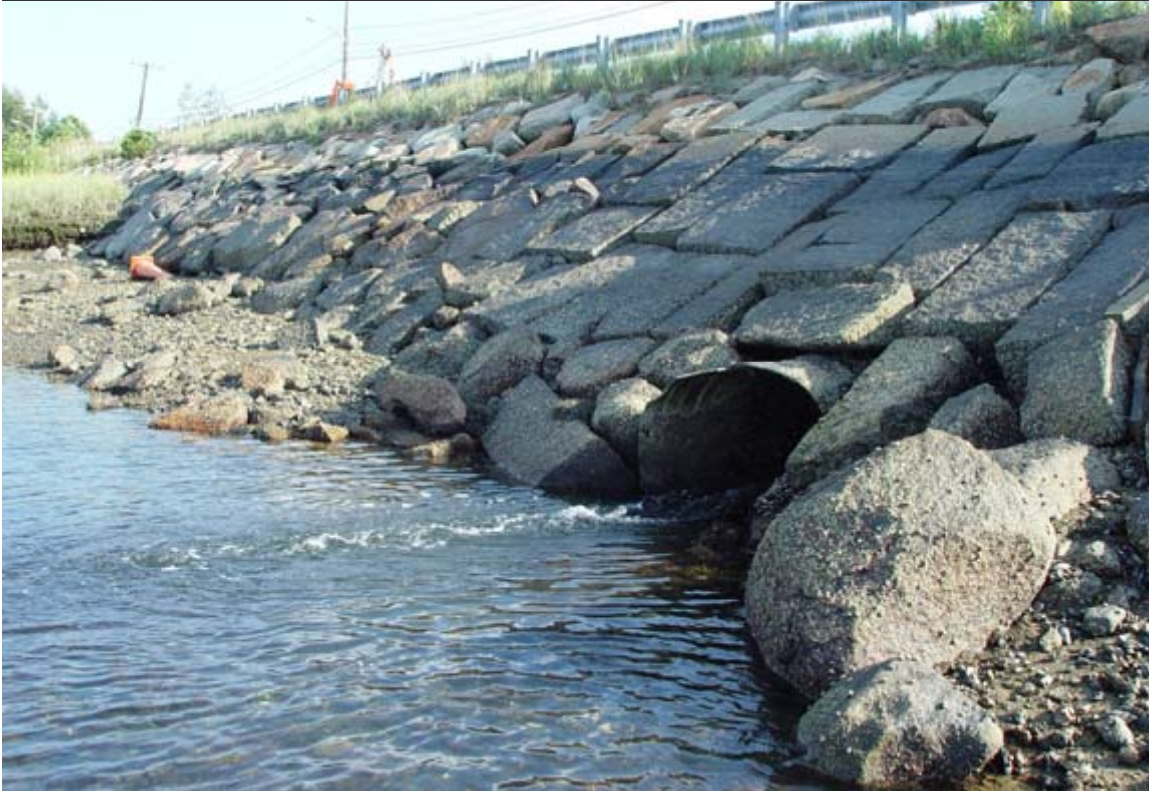
Photo 1 - Downstream View of Culvert

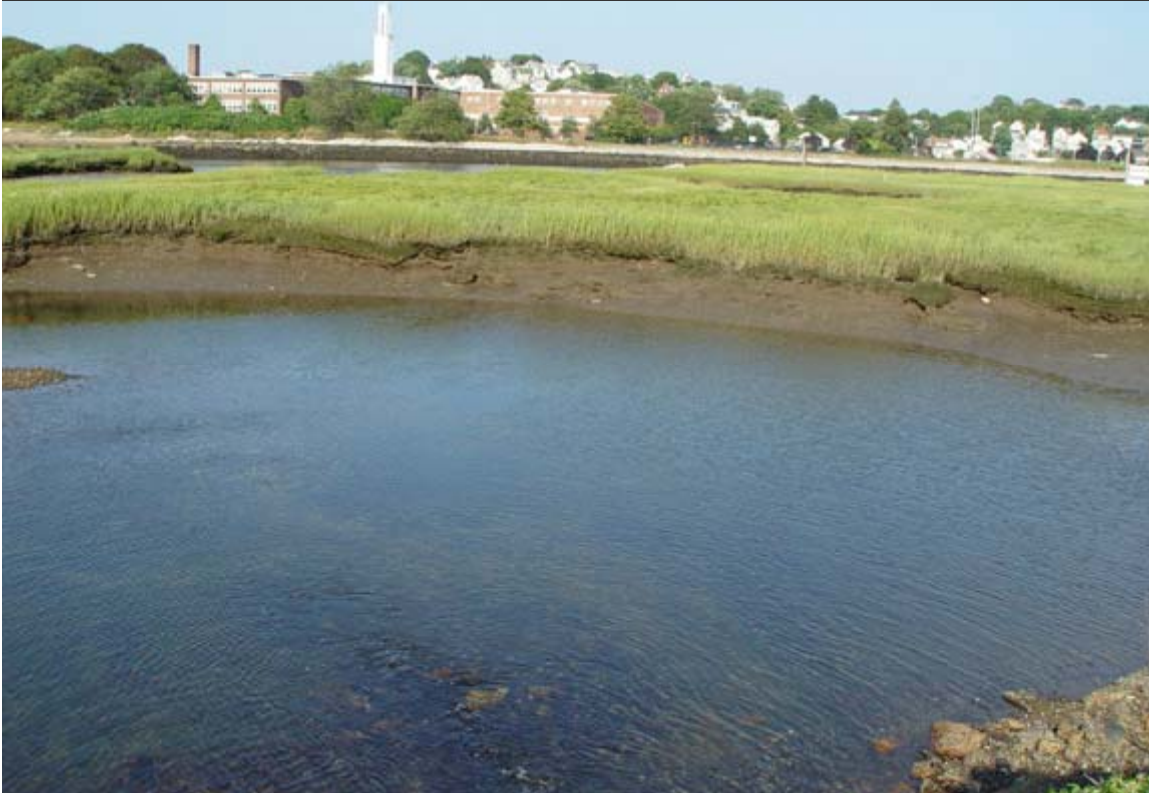
Photo 2 - Scour Pool and Marsh Downstream of Crossing

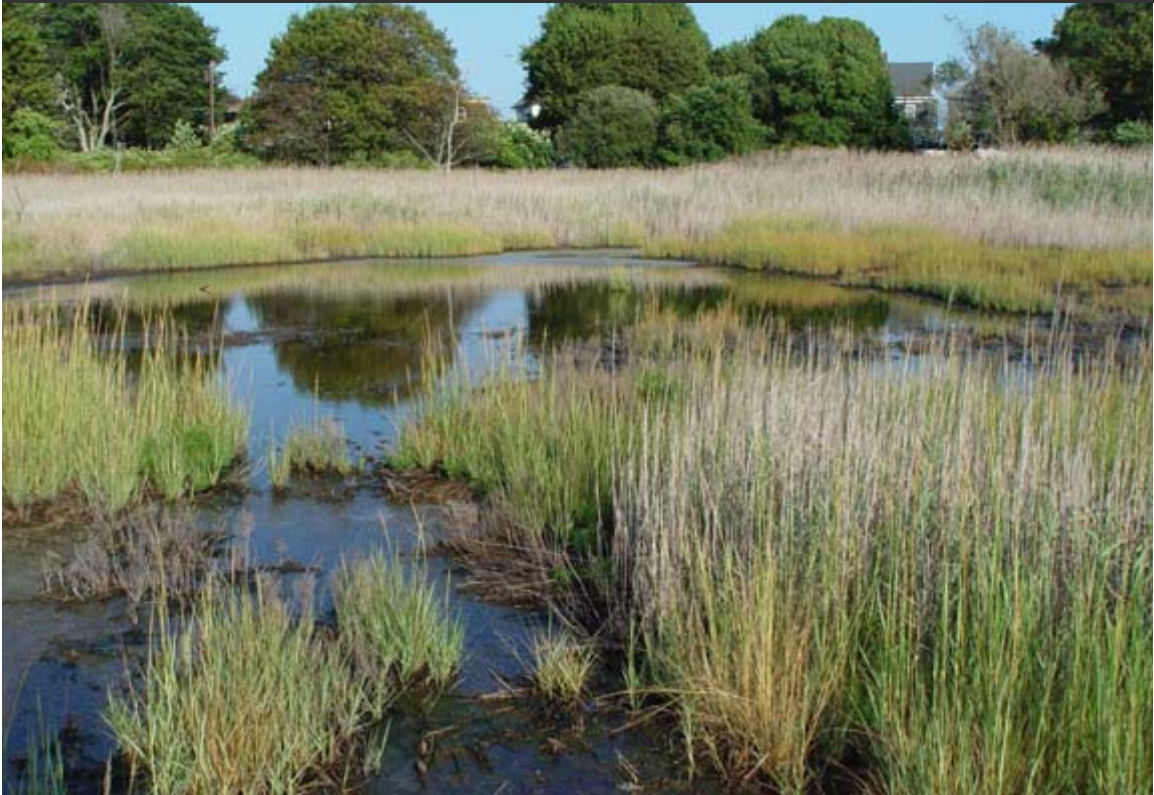
Photo 3 - Salt Panne within Southern Site

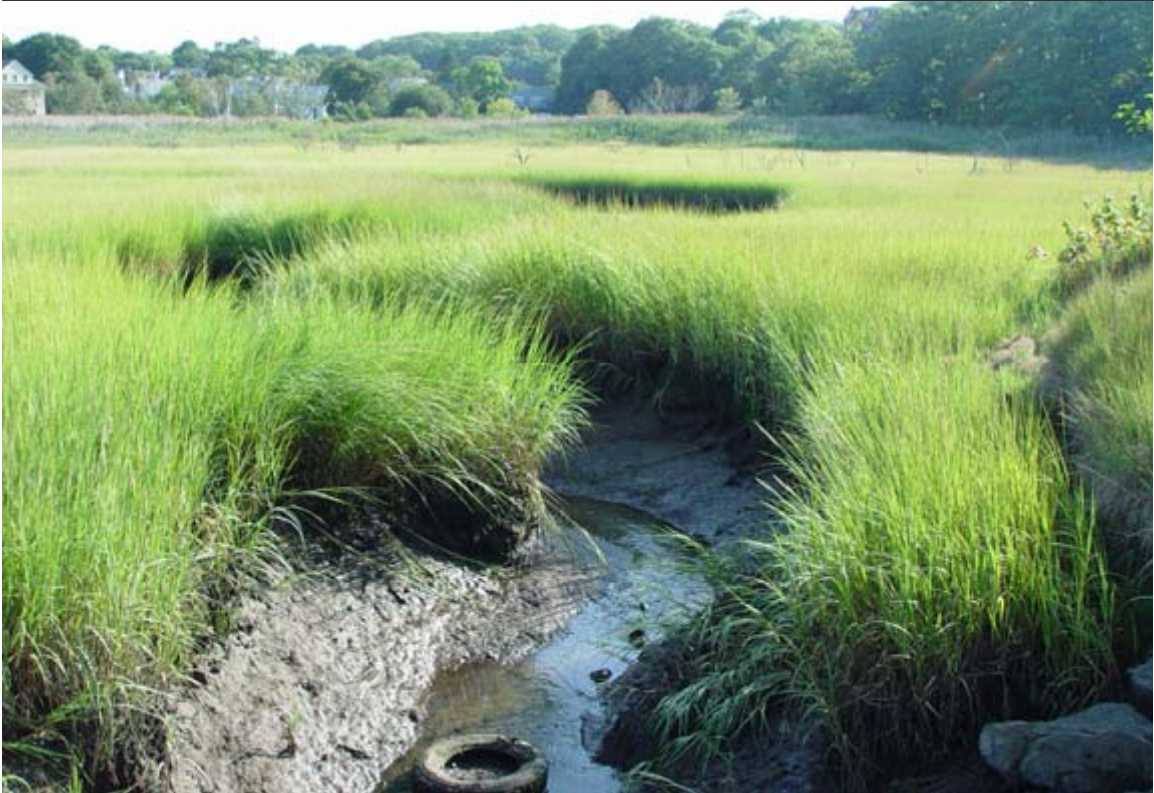
Photo 4 - Salt Marsh within Southern Site Upstream of Culvert

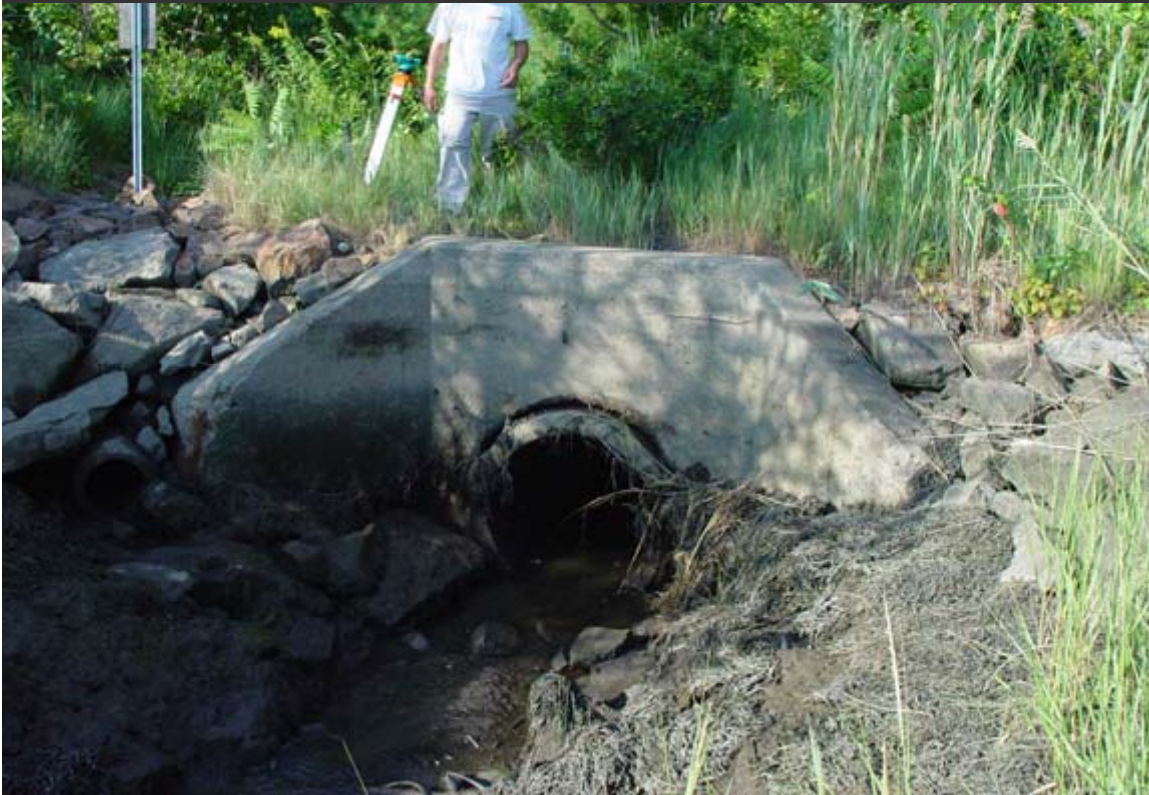
Photo 5 - Upstream View of Culvert In Southern Site

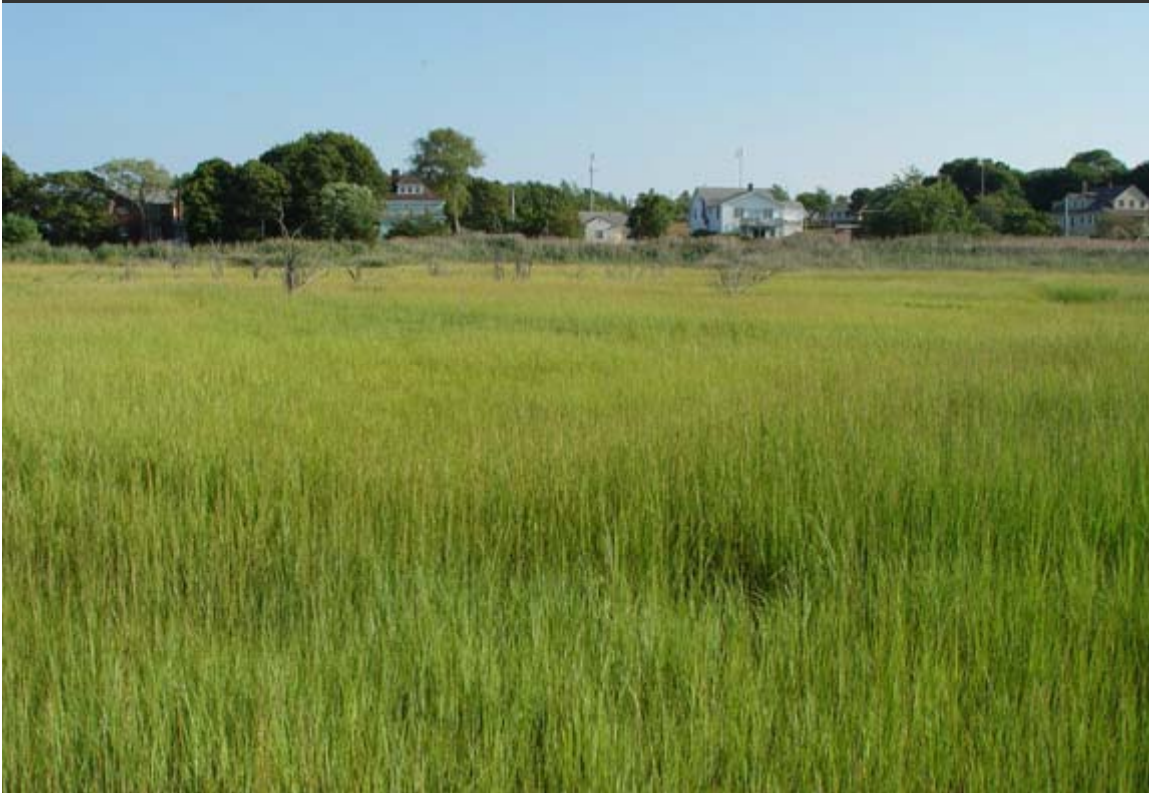
Photo 6 - Salt Marsh within Southern Site Viewing South

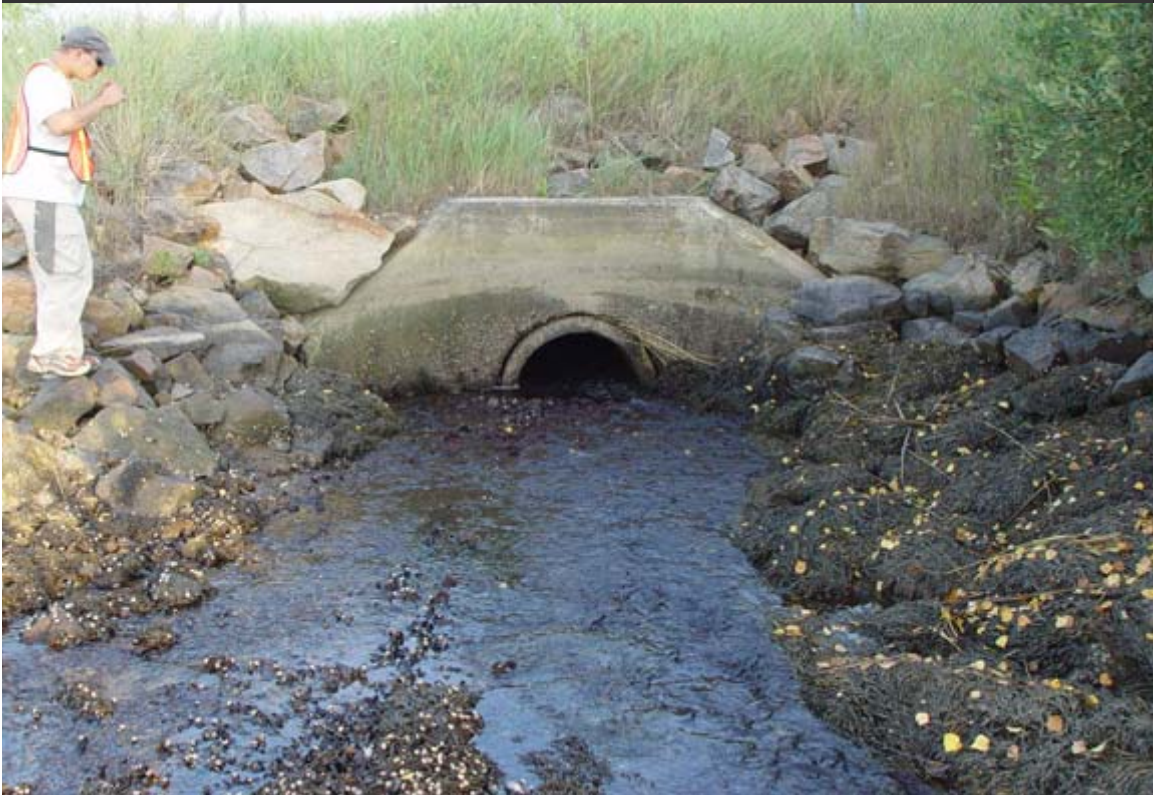
Photo 7 - View of Upstream Culvert within Northern Site

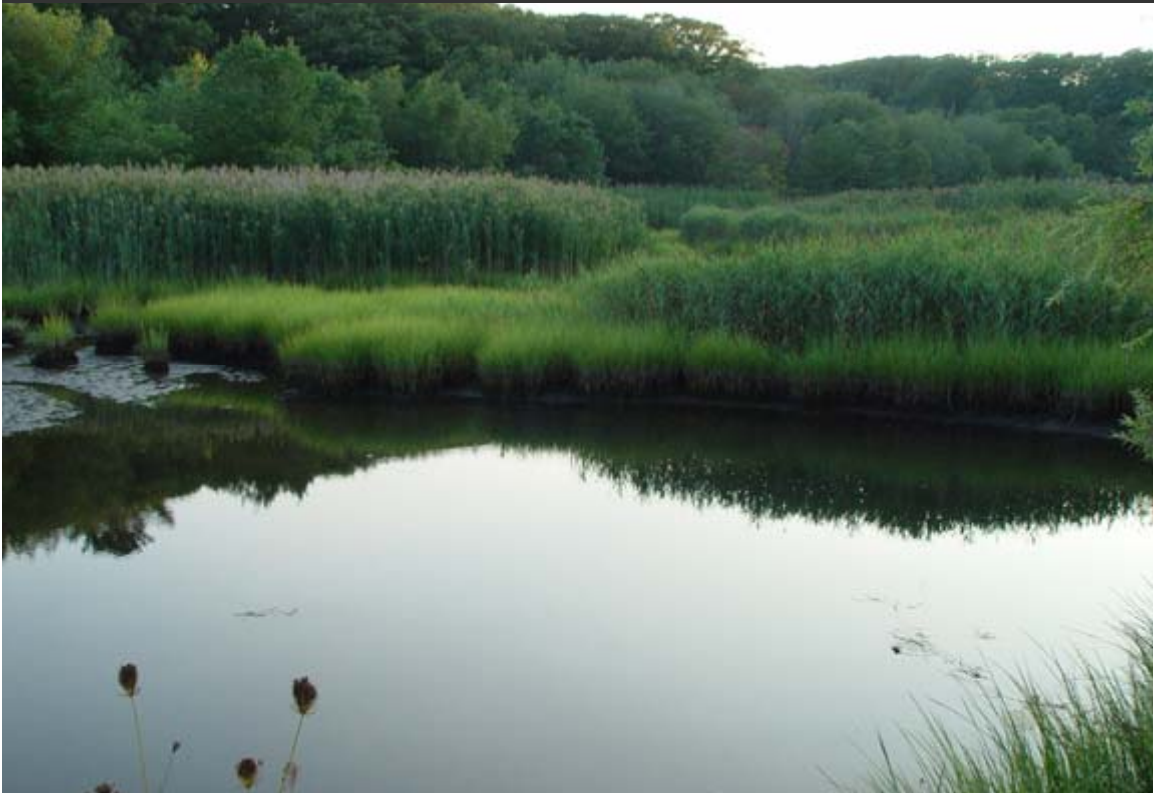
Photo 8 - Upper Reach of Northern Site

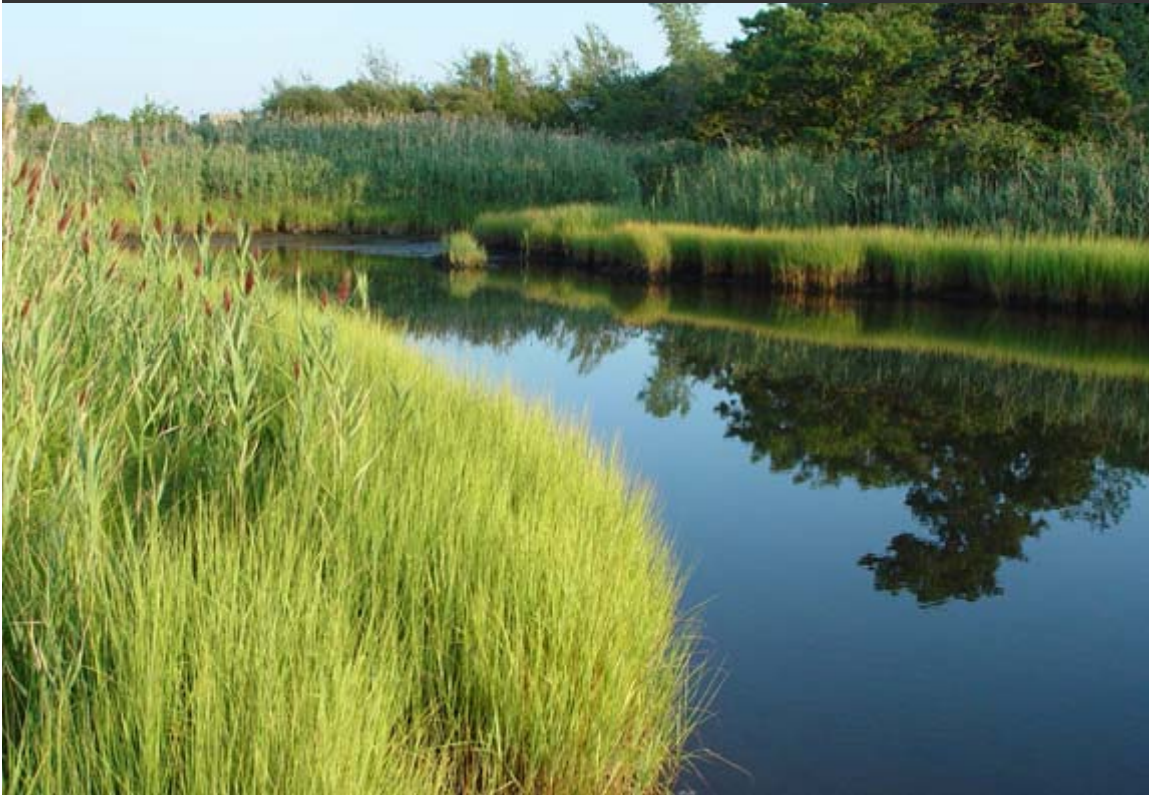
Photo 9 - Central Portion of Northern Site

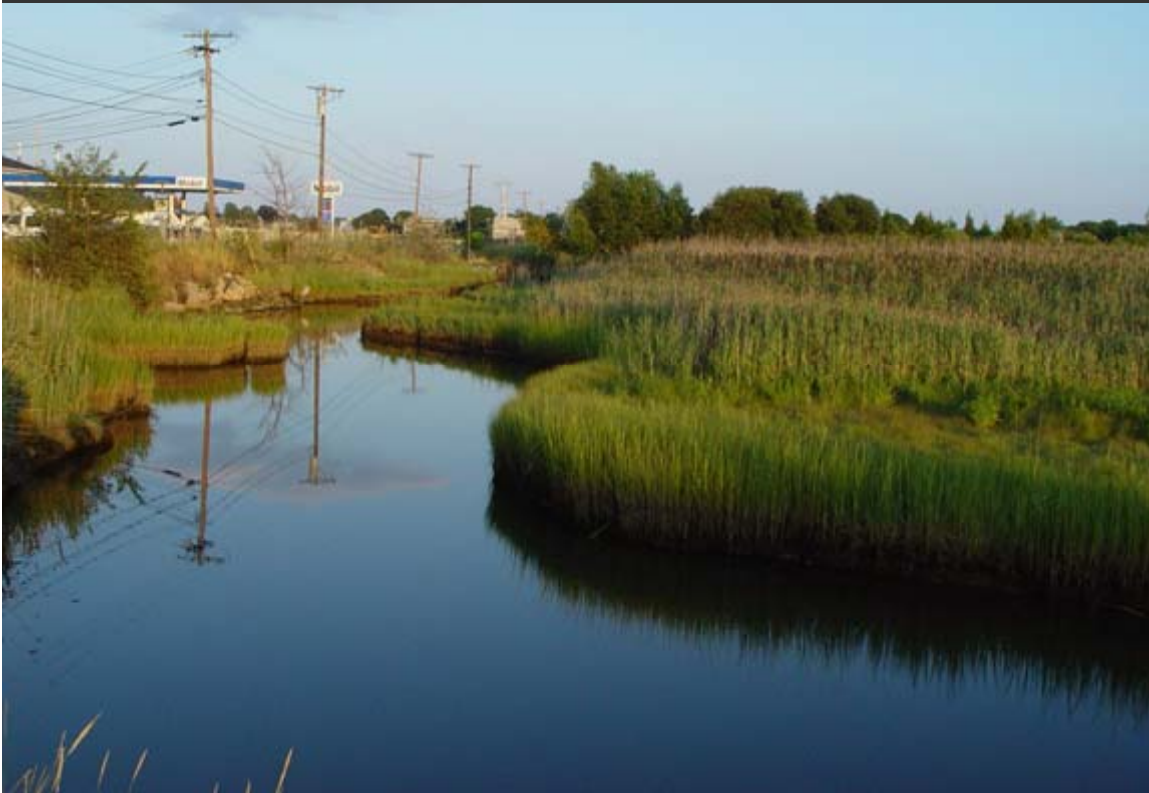
Photo 10 - Northern Site Viewing South
